Expedited Methods for Assessing and Mitigating Physical
and Chemical Hazards at Abandoned Mine Sites
Gaynor Dawson, Ted Richan, Jeff Dawson

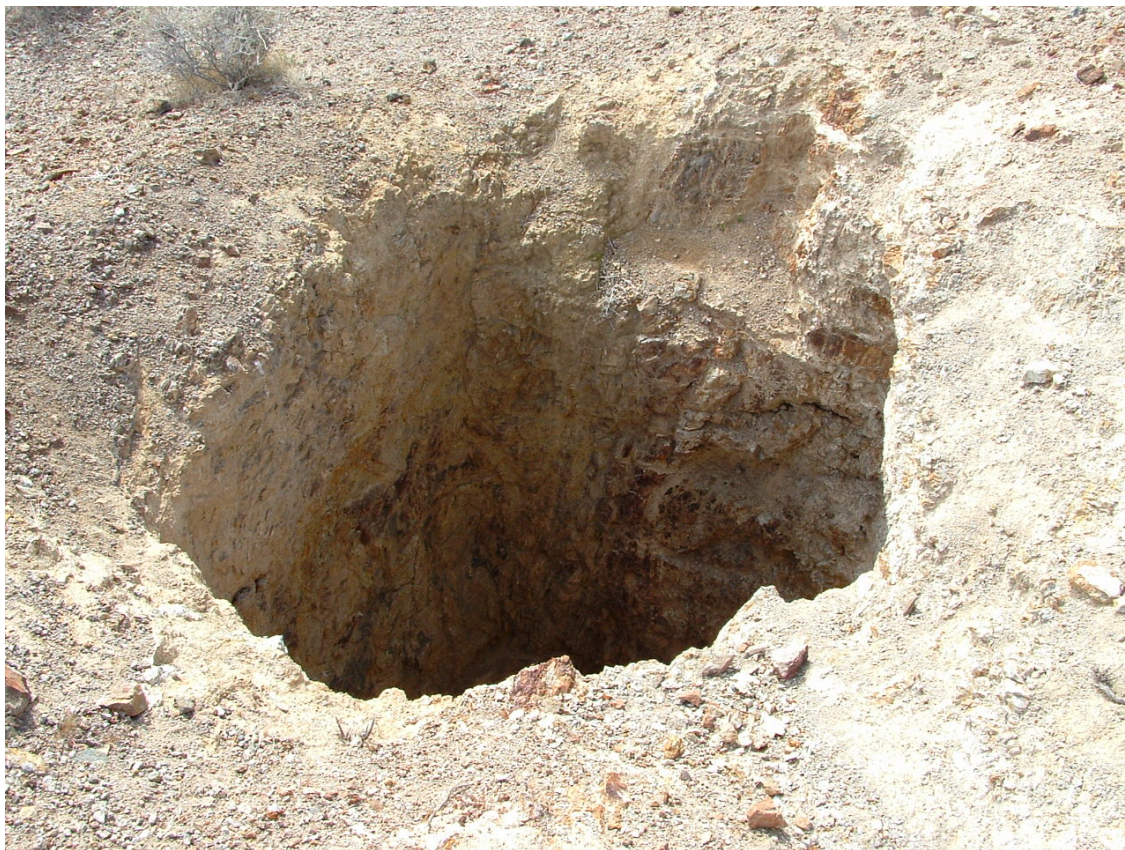
Figure 5. Mine WA-63 Shaft

Shafts (Figure 5), unstable surfaces, and sheer walls (Figure 6) are of particular concern because of the danger they pose to soldiers training in the area, especially when exercises are run at night. The anticipation of training with tanks dramatically increases the weight bearing capacity required for the unstable surfaces in areas where slopes are not too great for tank operations.

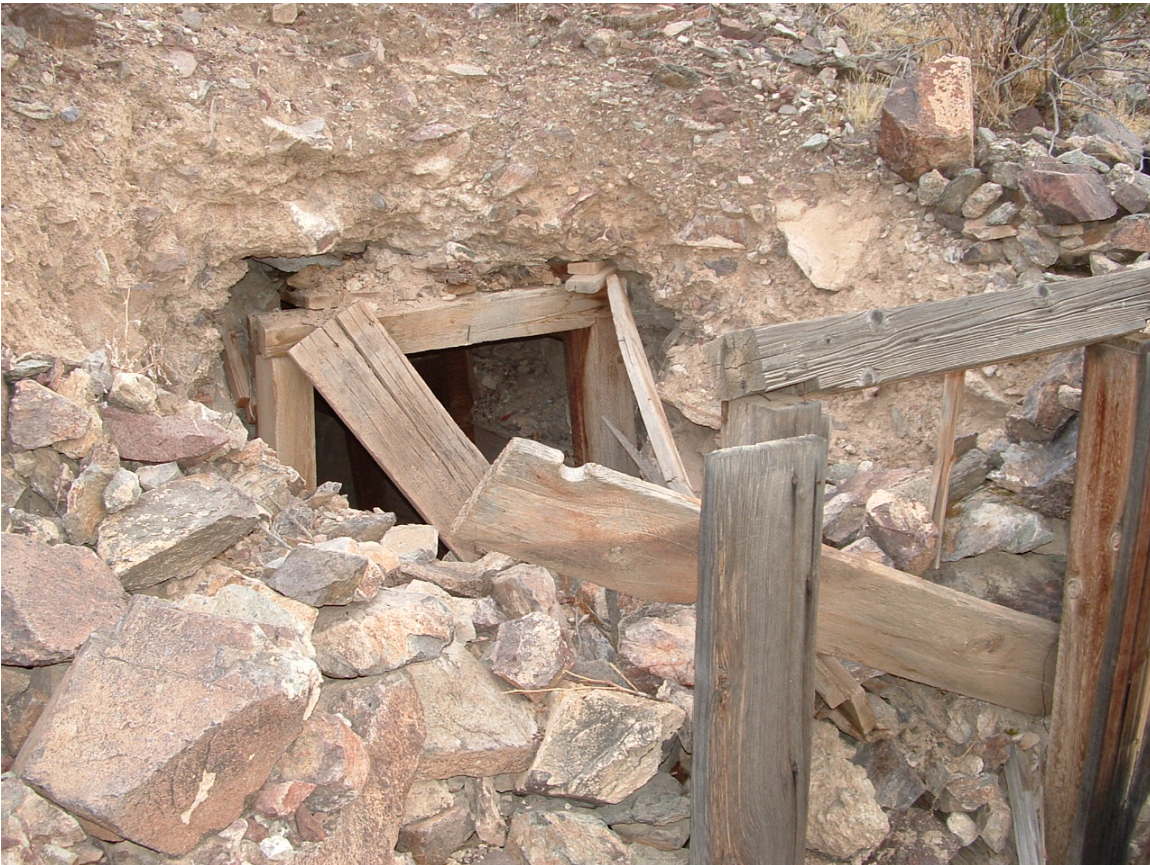
Figure 7. Crackerjack #3 Mine

The adits (Figure 7) were inventoried both as assets and potential hazards. As a consequence of the conditions under which current military operations are being conducted, there is some interest within the Army to have tunnels and cave-like structures available for training purposes. As such, any adit that was more than 15 feet in length and had an opening at least five foot high was marked for evaluation as a special training area. Supplemental evaluations in the form of structural integrity and air quality testing are planned for any adit deemed of interest for future training.

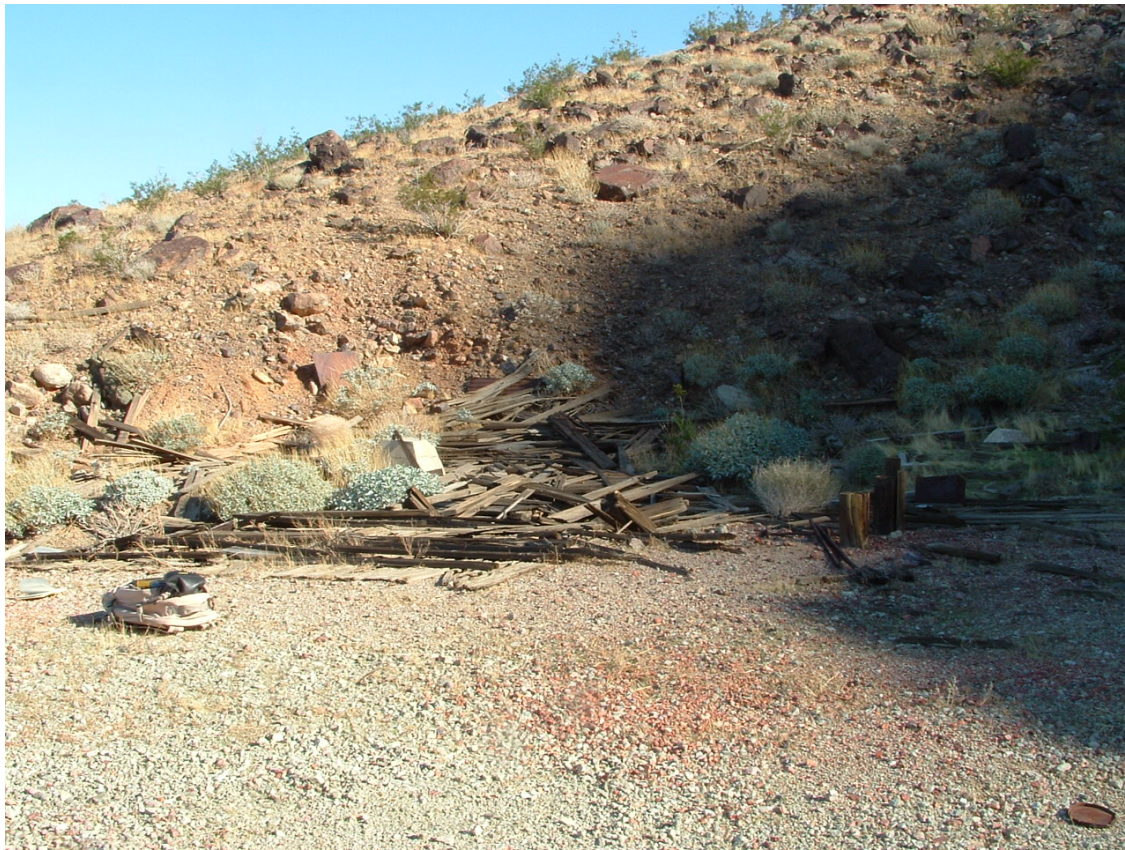
Figure 8. Debris at Red Pass Mine #1

In addition, to the primary physical hazards, a number of sites were noted to have a variety of debris such as boards with nails (Figure 8). These features were marked for removal or mitigation to reduce the risk of puncture during night training exercises.

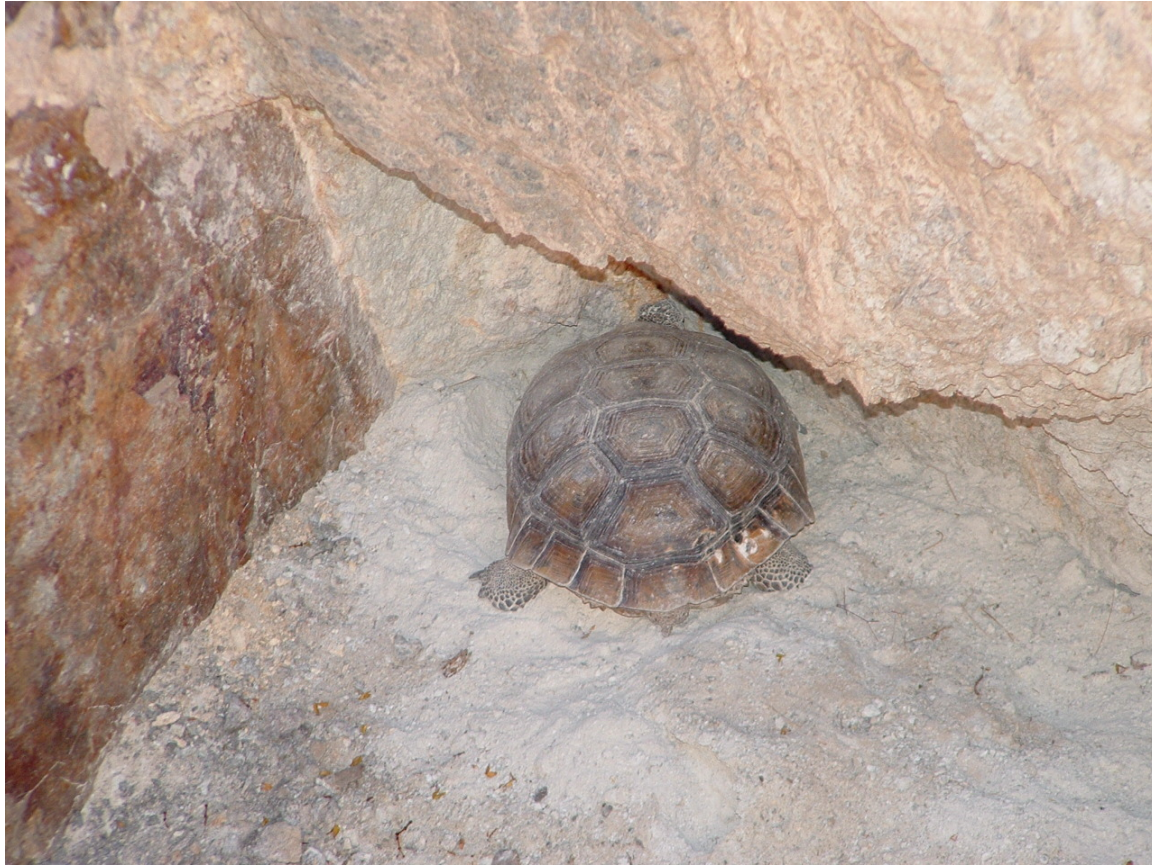
Figure 9. Desert Tortoise Trapped in Prospect Pit

With regards to the desert tortoise, it was observed that prospect pits too shallow to pose a threat to soldiers could act as a trap for these endangered animals. Many of the pits were found to have sheer walls that the tortoise can not surmount if it happens to fall in. The field team observed one tortoise dead in such a prospect and rescued a second that was similarly trapped, but still alive (Figure 9). In response to this discovery, a fifth hazard type was created: pits that could act as tortoise traps.

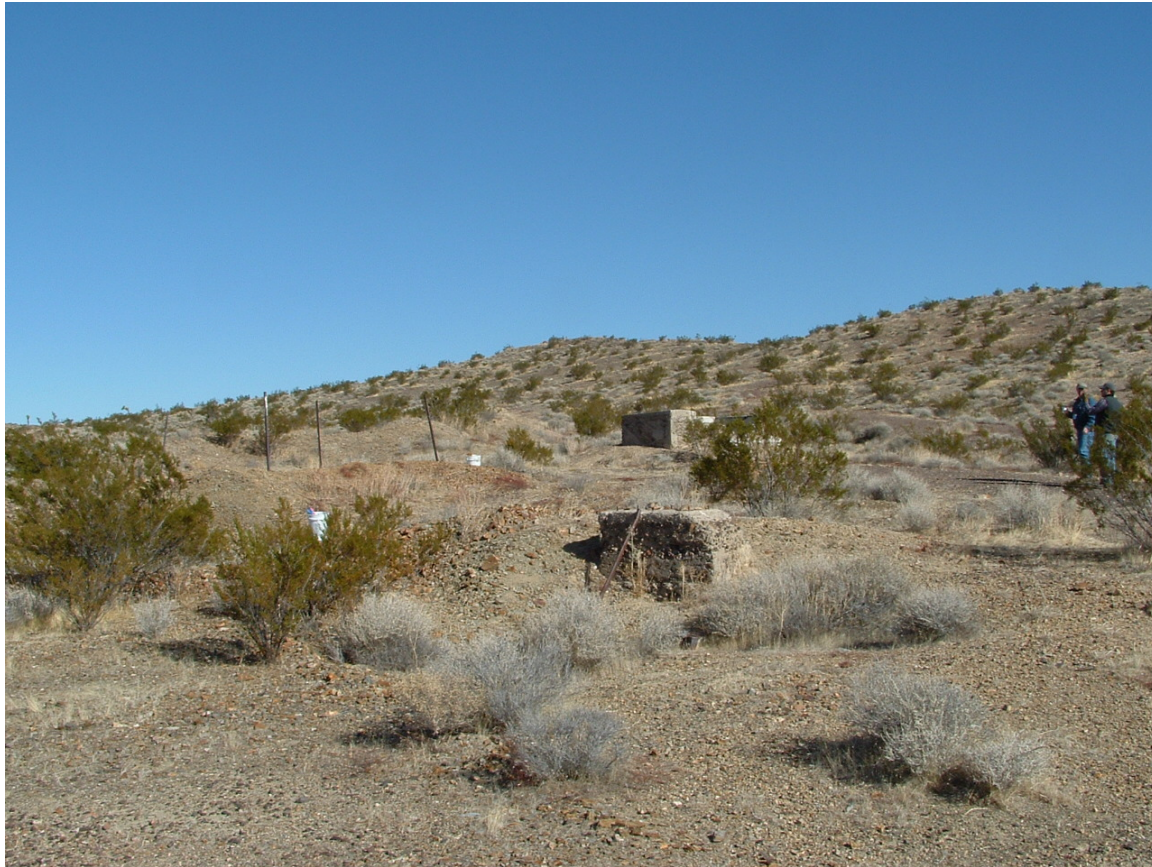
Figure 10. Barbed Wire Fence Around Shaft at Mine WA-32a

Temporary fencing can be as simple as a three strand wire configuration such as was encountered at one of the sites (Figure 10) or a more challenging design using three rolls of concertina in a pyramid configuration (Attachment A). Fencing of either design is recommended when the ultimate nature of use or design of final closure is still undecided. As an example, some of the remote mines had not had an official bat survey conducted at the time that access restrictions were needed. Similarly, when expensive closure designs were appropriate, budget constraints could necessitate temporary closure until funds are available.

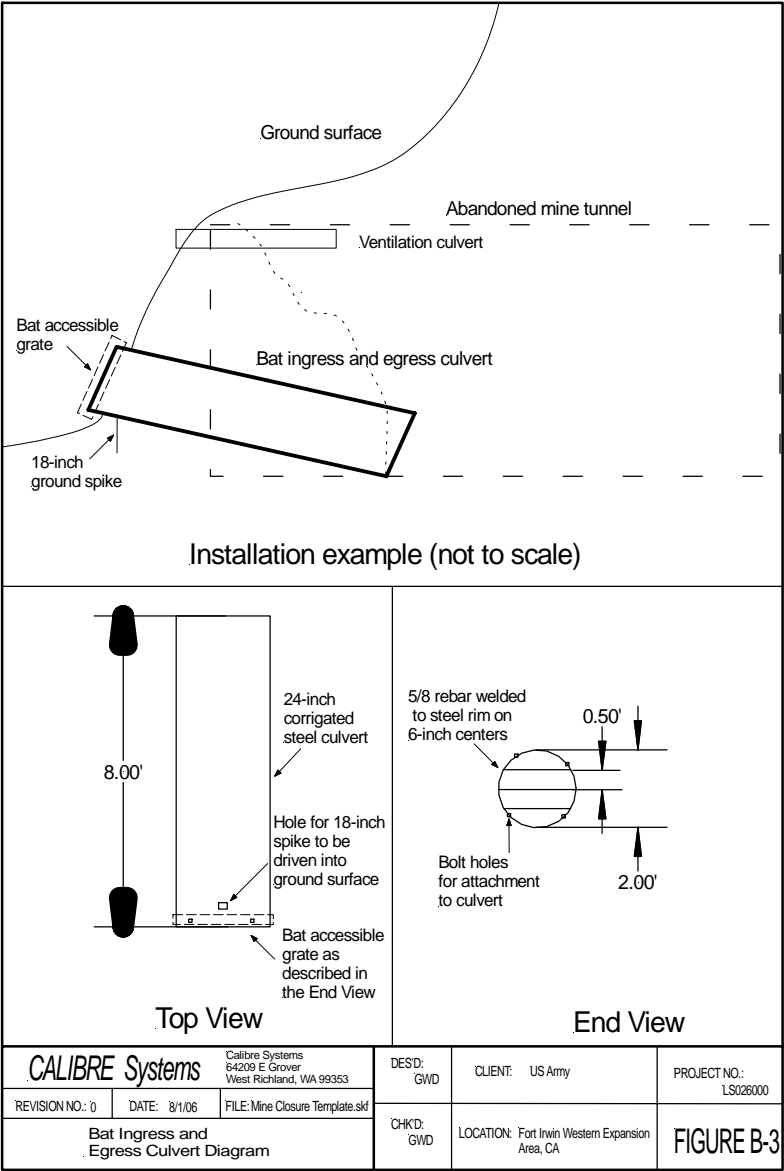
Figure C-3. Example of Culvert Installation and Specifications

An alternative method of closing the adit openings to humans, but allowing for bat entrance is to use a bat culvert, illustrated in Figure C-3. This design also meets the requirements for burrowing owl ingress and egress. An eight-foot long steel culvert is placed at a slight angle into the adit opening; a constructed grate is then bolted over the exposed opening allowing for bat or burrowing owl ingress and egress. To hold the culvert in place, an 18-inch spike is driven into the ground surface through a bolt hole near the exposed entrance of the culvert. Once the culvert is in place the opening of the adit is collapsed around the culvert closing the opening and preventing access without a concerted effort. A four-foot section of six-inch culvert is inserted at the top of the entrance fill to promote air circulation in the bat and burrowing owl habitat area.
